TWO MULTI-MILLION-DOLLAR LAWSUITS IN ONE DAY

Jury: \$21 Million Judgment Against Indy Door Dealer

New Jersey Door Dealer Faces \$3.5 Million Judgment

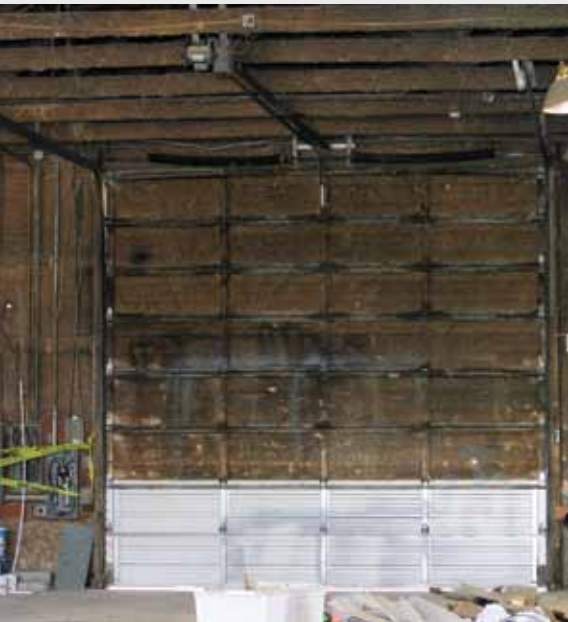
THE SCENE OF THE ACCIDENT: This is the 16' x 16' garage door and the trolley operator involved in the accident. The two replacement sections had been installed a week earlier. (Photo used with permission.)

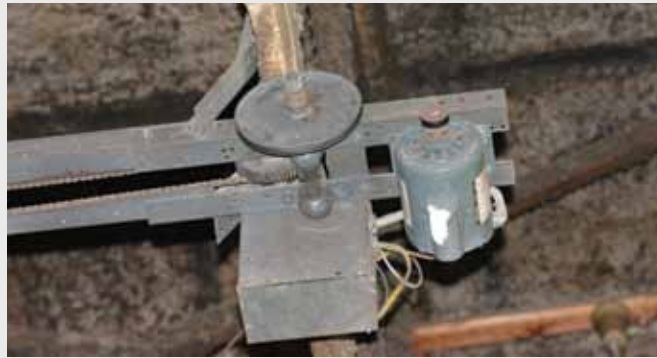
THE OPERATOR INVOLVED: This operator, thought to be 30 years old, is missing its belt because it had burnt off during the accident. (Photo used with permission.)

The operator motor's pulley belt finally burned off (it was later found on the ground).

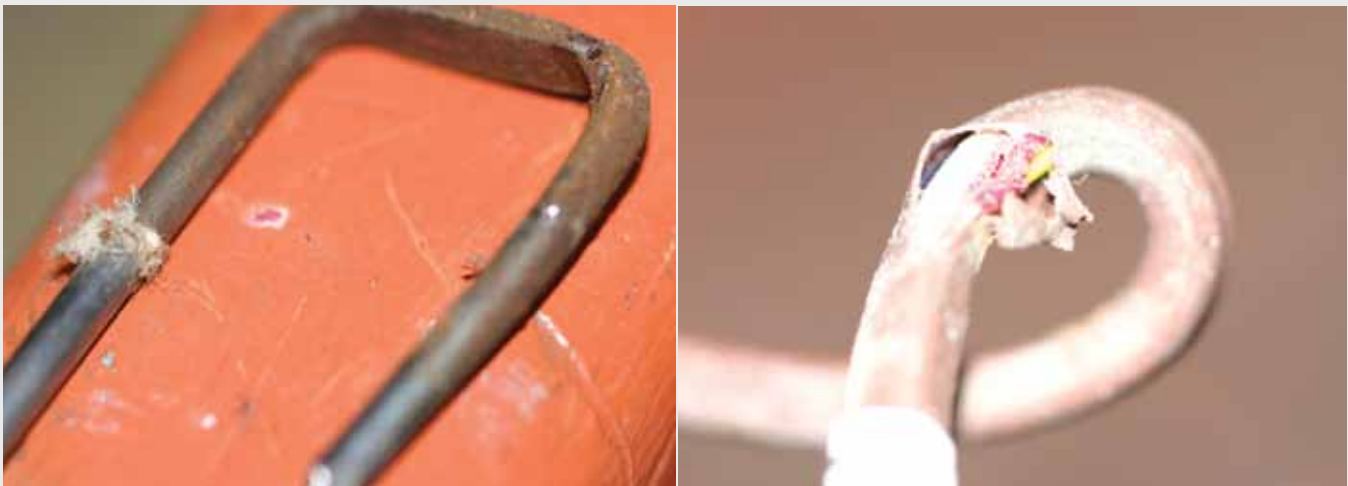
At that location in the wire, a bare metal staple had been used (probably in the 1980s) to attach the wire to the wall. Whatever Parker did caused the metal staple to make contact with the bare wire inside the wire's insulation. That contact created a spark, and the garage door began to open right in front of him.

BARE METAL STAPLE: This staple is believed to have cut through this wire, causing the door to open when Parker handled it. (Photo used with permission.)

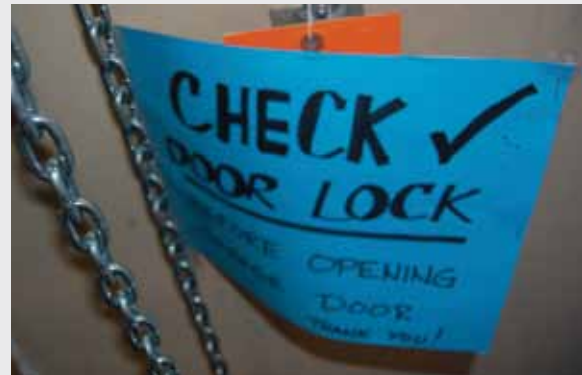
THE SIGN: This sign, placed by Cort Furniture Rental, warned to check the lock before opening the door. (Photo by Dynamic Evidence of Fort Lee, N.J. Used with permission.)

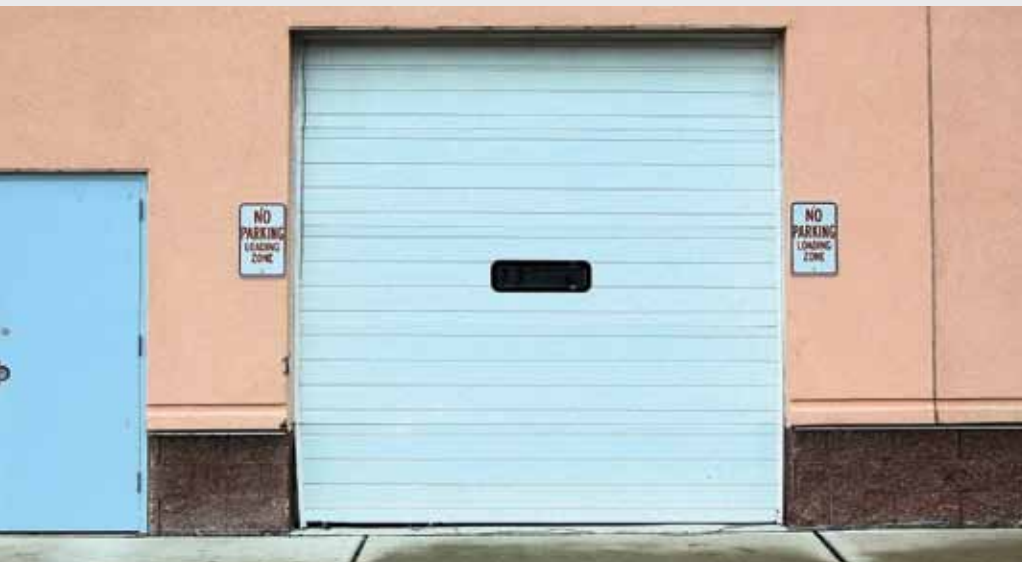
THE DOOR: The accident occurred at the left side of this door. The stepladder had been placed under the open door, in the doorway. (Photo by Dynamic Evidence of Fort Lee, N.J. Used with permission.)

“There is no evidence that answers the question of why the door dropped,” said Breslin. Photographic evidence later showed that the cable on the left-hand side of the door had snapped.

Here's the key issue: Groenewal/Ramsey did not install an interlock safety switch, which Breslin said was "the standard practice in the industry." An interlock safety switch would have disabled the operator when someone attempted to use it while the door was (manually) locked.

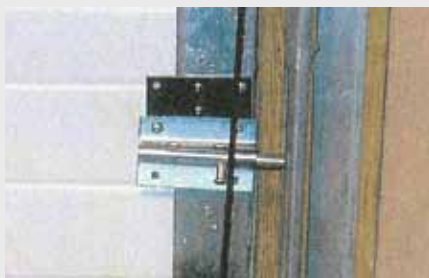
At some point after that incident, Cort removed the end-stile lock and installed a sliding bolt lock. It was later learned that the new lock was not a type recommended by the door manufacturer.

THE LOCK: This slide lock, installed by Cort, was thought to be involved in the chain of events that led to the accident. (Photo by Dynamic Evidence of Fort Lee, N.J. Used with permission.)

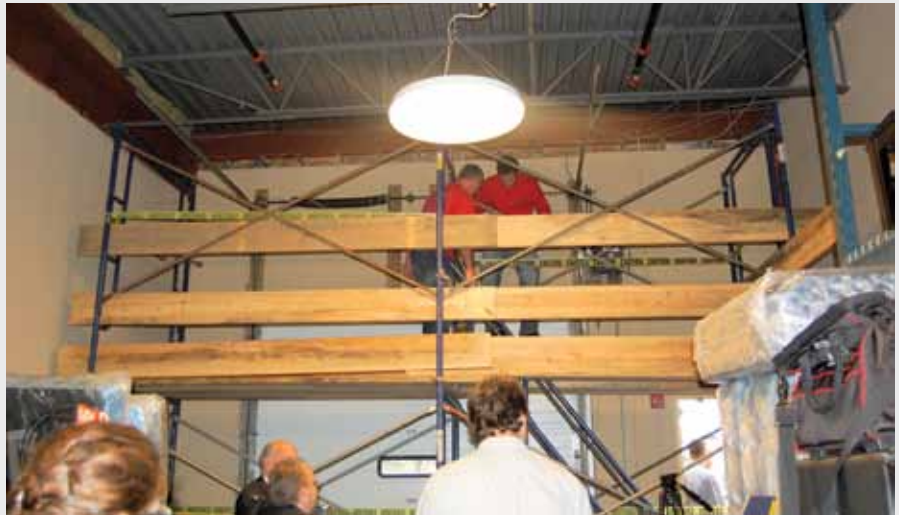
THE INSPECTION: A large team of investigators descended on the accident scene to try to determine what happened. (Photo by Dynamic Evidence of Fort Lee, N.J. Used with permission.)
